Mechanization of Wagon Cleaning process on Vitoria a Minas Railroad

Brás Senra de Oliveira

Vale S/A, São Luís, Brazil

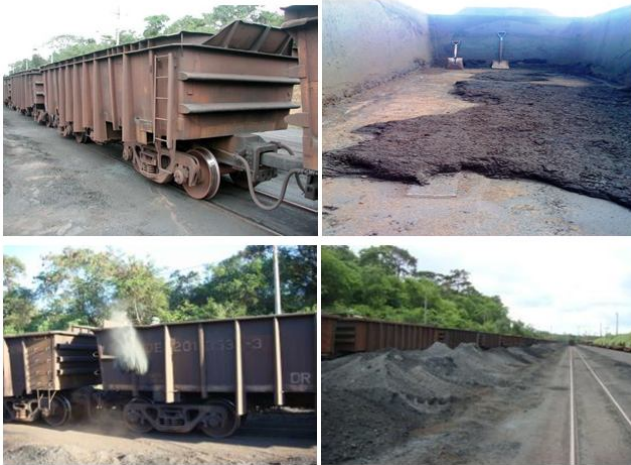
Figure 1. Wagon cleaning process

Figure 1 helps us to visualize the manual wagon cleaning process. The first photo (upper left) shows the GDE type wagon (gondola type). Access to the interior of the wagon is performed using the side ladder at the ends of the wagons. The second photo (upper right) shows the interior of a wagon in rainy seasons with a high volume of material to be removed resulting in slow task completion. The third photo (bottom left) shows the employee performing the cleaning of the wagons using shovels, this image gives us a sense of how slow the task was. The last photo (bottom right) shows us the place of work after the end of the wagon cleaning, where there was high contamination of the ballast and also mineral waste scattered along a long stretch of the cleaning yard.

Briefly describing the task, the employee of the outsourced company had to climb into the wagon and perform the cleaning using shovels, hoes and picks. Figure 1 and 2 help us to understand the process.

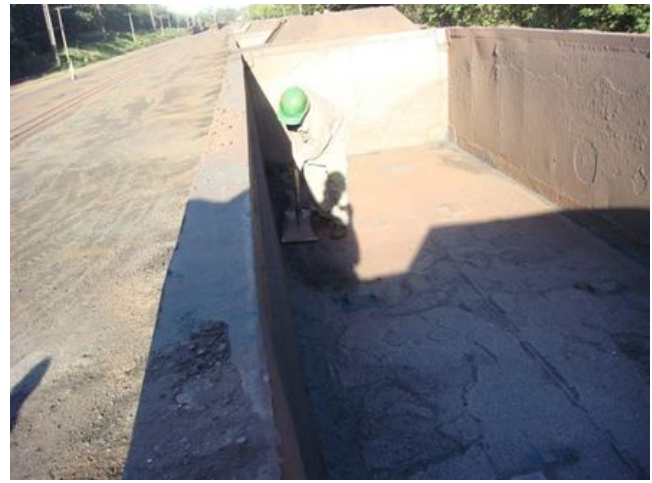
Figure 2. Manual wagon cleaning – using shovels

Figure 2 details the working condition which the employees were subjected to, where the cleaning of the wagons was performed manually by using shovels.

As we saw in Figure 2, the activity was performed slowly, in the open, under unsatisfactory ergonomic conditions. In order to increase the productivity of the process, improve the working conditions of the teams and also reduce the costs of third-party contracts, the need for mechanization of the process arose.

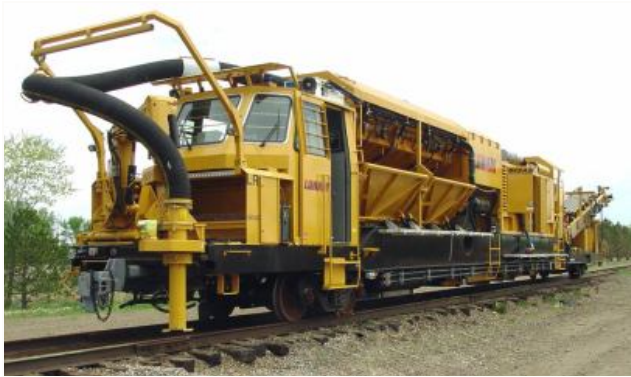
Figure 3. ballast vacuum cleaner

In 2010, Vale had acquired new equipment called a "ballast vacuum cleaner". This equipment consists of

two diesel engines, with a vacuum pump connected to each engine. These pumps generate negative air flow (vacuum), and then suck the rail ballast to be cleaned. Figure 3 shows the equipment.

It was realized that the operating principle of the equipment could be replicated in the cleaning of wagons. A test was planned where the ballast vacuum was positioned on a line next to a gondola wagon and it was attempted to clean this wagon. It was seen that the equipment had limitations to clean this due to the fact that it was not designed for the task, however, at the points where the equipment was able to reach the bottom of the wagons it was possible to carry out the cleaning in a satisfactory way.

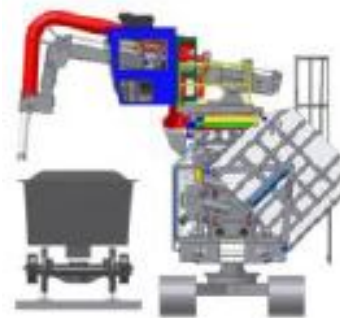
Figure 5. Machine discharge conception

Access to the cabin is provided by caged ladders installed opposite the railroad track. It was also imagined that the material removed from the wagons should be unloaded next to the equipment so excavators could be used to remove it and bring it to the wagon car-dumpers. In this way 100% of the material would be used. Figure 5 shows the design of the machine discharging.

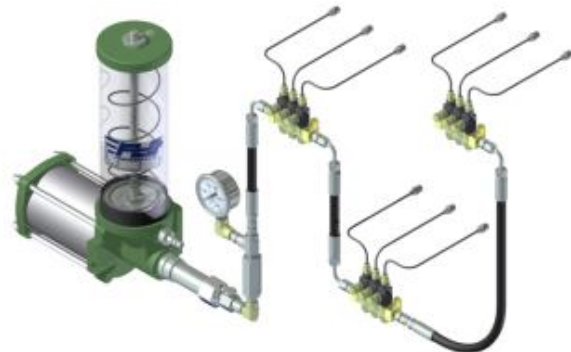
Figure 8. Automatic lubricating system

The operating cab frame, on the top of the equipment has several moving parts as well as in the suction nozzles arms. The machine was designed to work 24 hours a day, so it was necessary to fit an automatic lubrication system for the moving parts, so there would be no need to stop the machine activity to perform the lubrication.

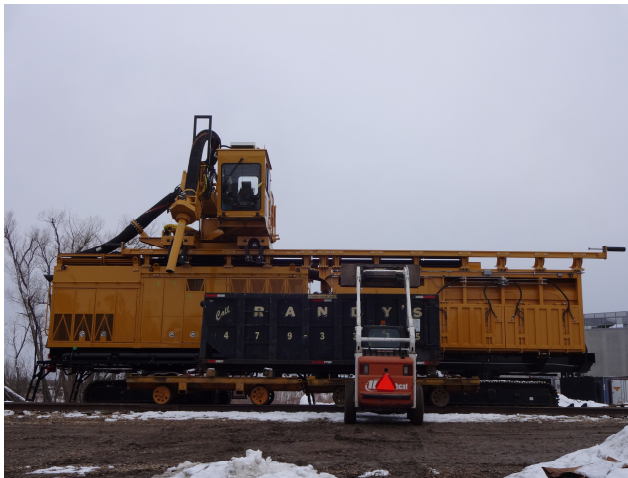
Figure 10. Frontal view of the equipment

The manufacturing of the equipment was completed in March 2014 and the test phase was performed at the manufacturer's headquarters.

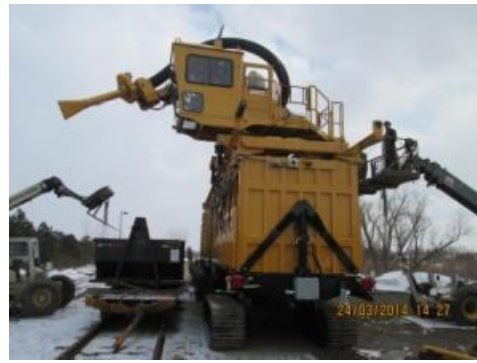
Figure 11. During validation tests

As it was an unprecedented project, the contract stated the validation tests of the project would occur at the manufacturer's headquarters. The objective of this was to evaluate the performance of the machine and if any anomalies were identified the repair would be immediate. These tests were carried out in March 2014, in the city of Hamel (USA).

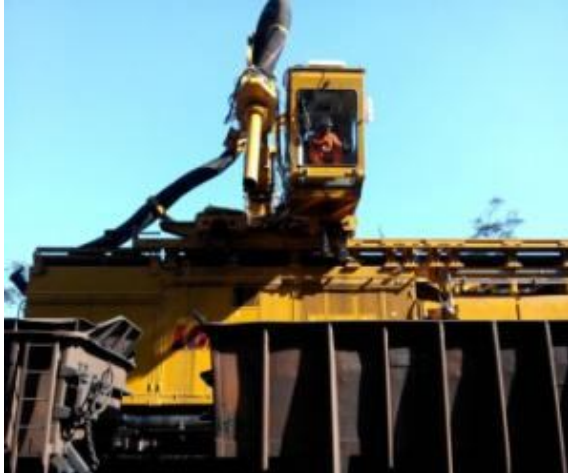
Figure 13. Equipment being operated by Vale's employee

After the tests and validations of the commissioning phase, the equipment entered into the operating rhythm at "full capacity". At the same time the machines started to be operated and maintained exclusively by Vale's crew.

The tests were witnessed by manufacturer, where the responsibility for the equipment was to help only in situations where the Vale team (due to the maturing of the knowledge) still had difficulties to intervene, or in operational failures due to machine design failures.
